XPS Analysis of Al/EPDM Bondlines from IUS SRM-1 Polar Bosses: Final Report

C. S. HEMMINGER and N. MARQUEZ
Mechanics and Materials Technology Center
Technology Operations

10 March 1993

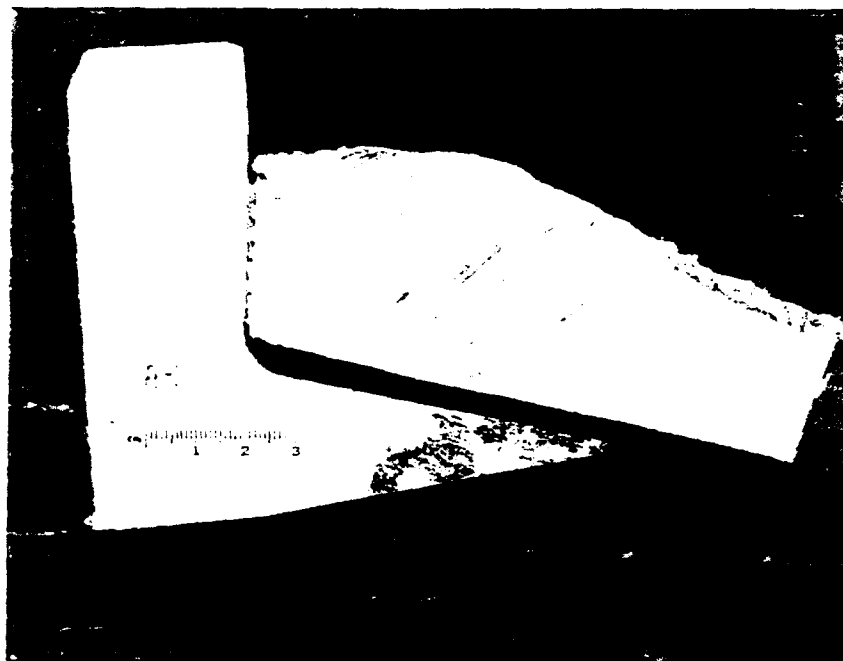
Figure 2. Polar boss slices from motor case S/N 114. a) Forward boss. b) Aft boss.

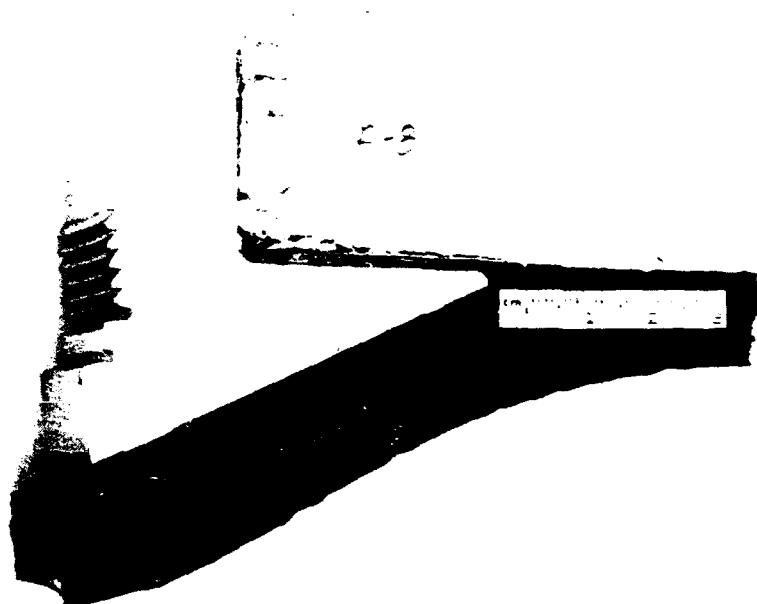
Figure 3. Polar boss slices from motor case S/N 029. a) Forward boss. b) Aft boss.
